Manhole Inspection Summary

Manhole # S15QQ_005MH

Location Address: **3201 LEIGHTON AVE**

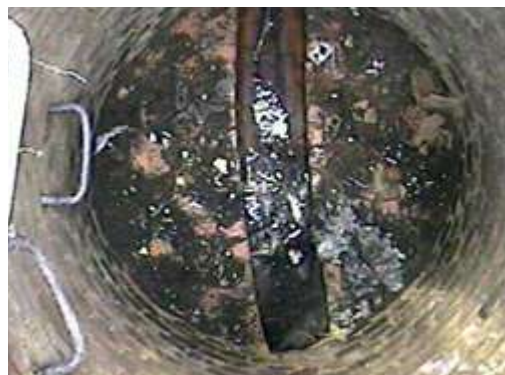
Top View

Condition: ☐ Sound ☐ Cracked ☐ Root Intrusion ☐ Deteriorated ☐ Leaks ☒ **Debris**

DEBRIS ON BENCH AND IN CHANNEL

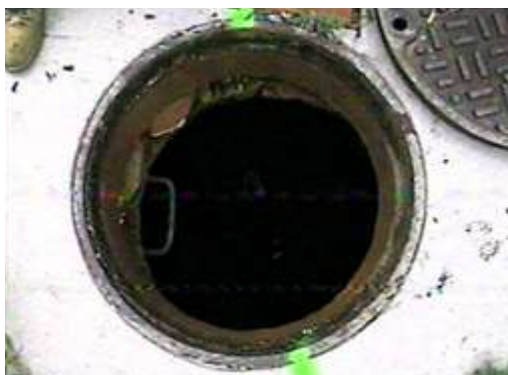
Top View

Offset: **2** (in.)

FRAME OFFSET

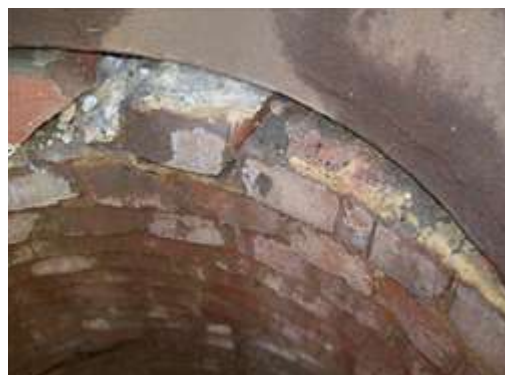
Defect 2

Condition: ☐ Sound ☐ Cracked ☐ Root Intrusion ☒ **Loose Brick** ☐ Deteriorated

CHIMNEY DETERATION

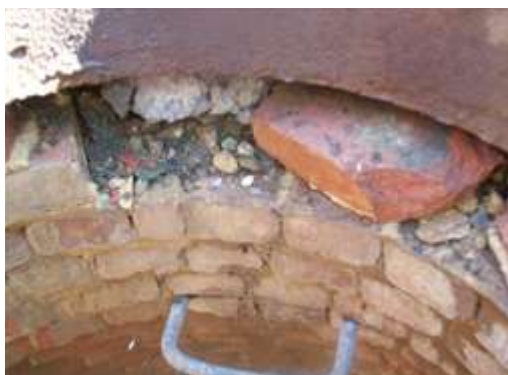
Defect 1

CHIMNEY DETERATION

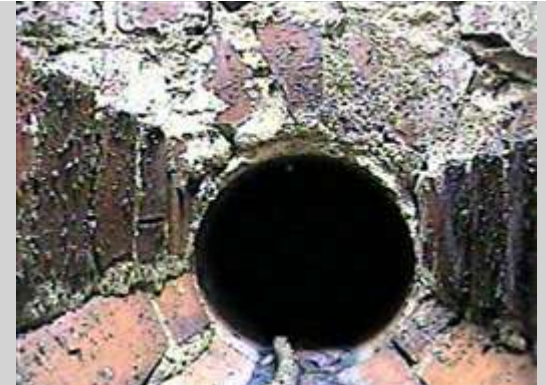
12 O'Clock Outflow

8 in. Circular Gravity Sewer
Pipe Out @ 12 O'Clock

Pipe Height: (in.) Direct
Pipe Material: **Clay** ☐ Pipe Lined
Invert Depth: **7.34** (ft.) Flow Characteristics: **Slow**
Deposits: ☒ None ☐ Mud ☐ ~~Gravy~~ ☐ **Debris** ☐ Grease
Silt Depth: (in.) Deposits Extent:
Infiltration: **None** Pipe Seal Cond: **Sound**

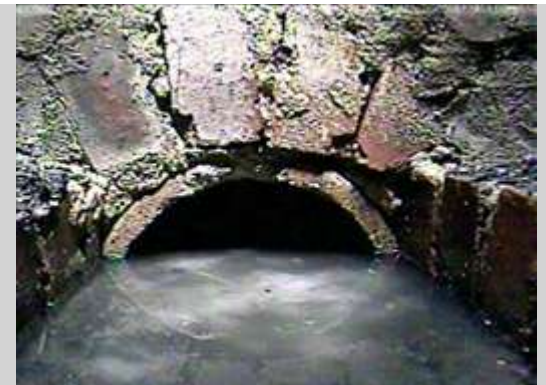
6 O'Clock Inflow

8 in. Circular Gravity Sewer
Pipe In @ 6 O'Clock

Pipe Height: (in.) Direct
Pipe Material: **Clay** ☐ Pipe Lined
Invert Depth: **7.31** (ft.) Flow Characteristics: **Slow**
Deposits: ☐ None ☐ Mud ☒ ~~Gravy~~ ☒ **Debris** ☐ Grease
Silt Depth: **4** (in.) Deposits Extent: **Medium**
Infiltration: **None** Pipe Seal Cond: **Cracked**
